Manhole Inspection Summary

Manhole # S25GG_001MH

Location Address: **1900 PENNSYLVANIA AVE**

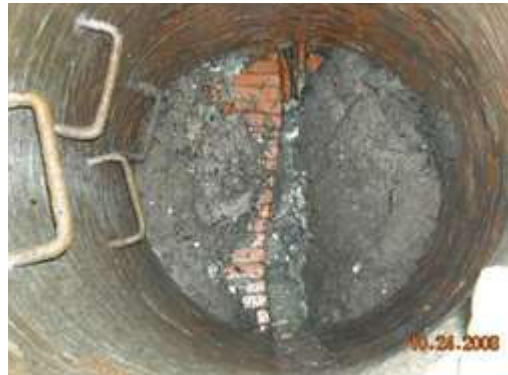
Top View

1st visit. Needs cleaning.

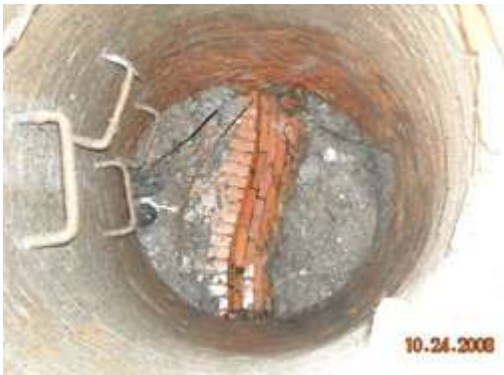
Top View

Corroded steps. Evidence of surcharge - Bench debris.

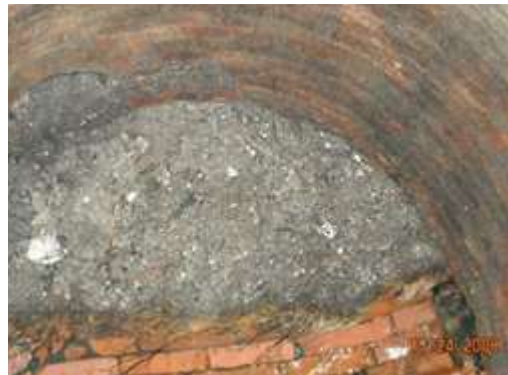
Defect

Comments **ORIGINAL INSPECTION BY PHOENIX ENGINEERING CREW: SP, DP 10/19/2007.
COMPLETED BY REI/DRAYCO
ROOTS IN PIPE PICS ARE ON THE BENCH FROM THE 3 O'CLOCK PIPE**

Bench/Channel root intrusion.

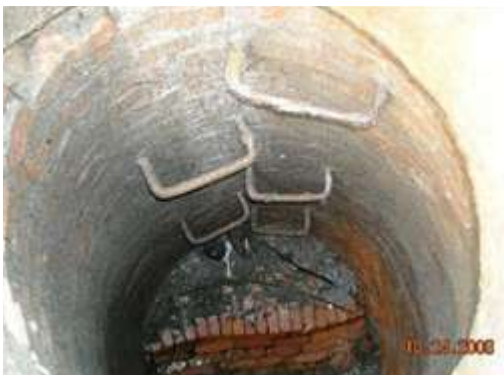
Defect

Frame leaks. Corbel deterioration, loose brick and infiltration. Barrel infiltration.

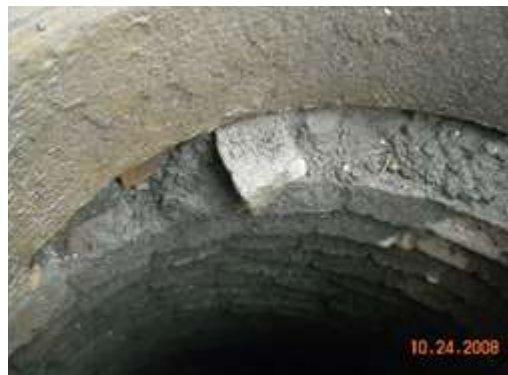
Defect

Frame leaks. Frame offset. Corbel deterioration, loose brick and infiltration.

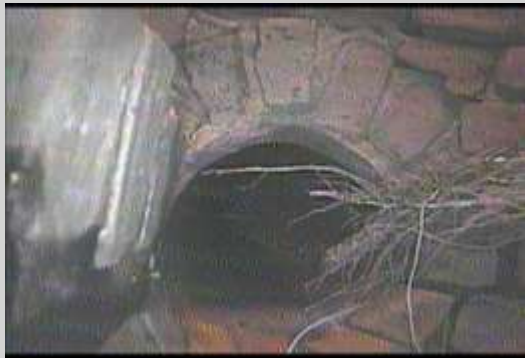
8 in. Circular Gravity Sewer Pipe Out @ 12 O'Clock

Barrel deterioration and infiltration. Channel deterioration.

Infiltration: **Evidence** Pipe Seal Cond: **Unknown**

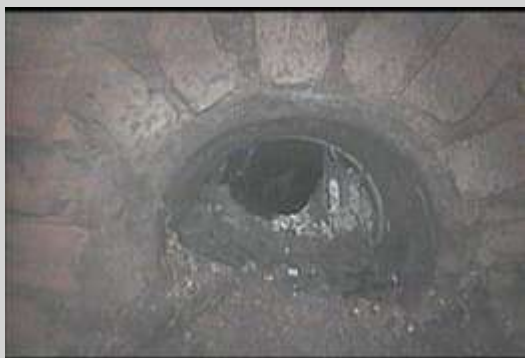
8 in. Circular Gravity Sewer Pipe In @ 3 O'Clock

Deposits: ☐ None ☒ Mud ☒ Sludge ☒ Debris ☐ Grease

Silt Depth: **6** (in.) Deposits Extent: **Heavy**

Infiltration: **None** Pipe Seal Cond: **Roots**

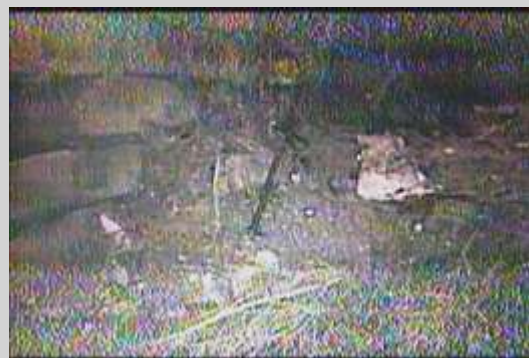
Drop In @ 3 O'Clock

Drop Condition: **Clogged**

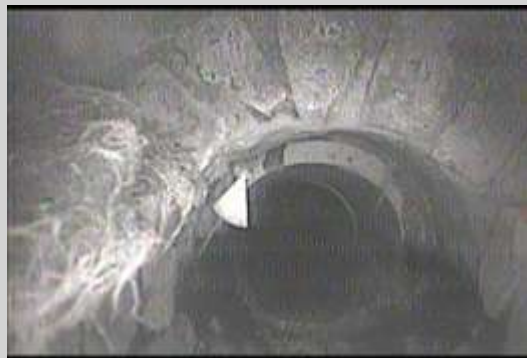
Pipe In @ 6 O'Clock

Infiltration: **Evidence**

Pipe Seal Cond: **Roots**
